DEPARTMENT OF THE ARMY  
ARMY CONCEPT TEAM IN VIETNAM  
APO San Francisco 96384

2 FEB 1970

SUBJECT: Final Letter Report - Night Flying Control System for UH-1

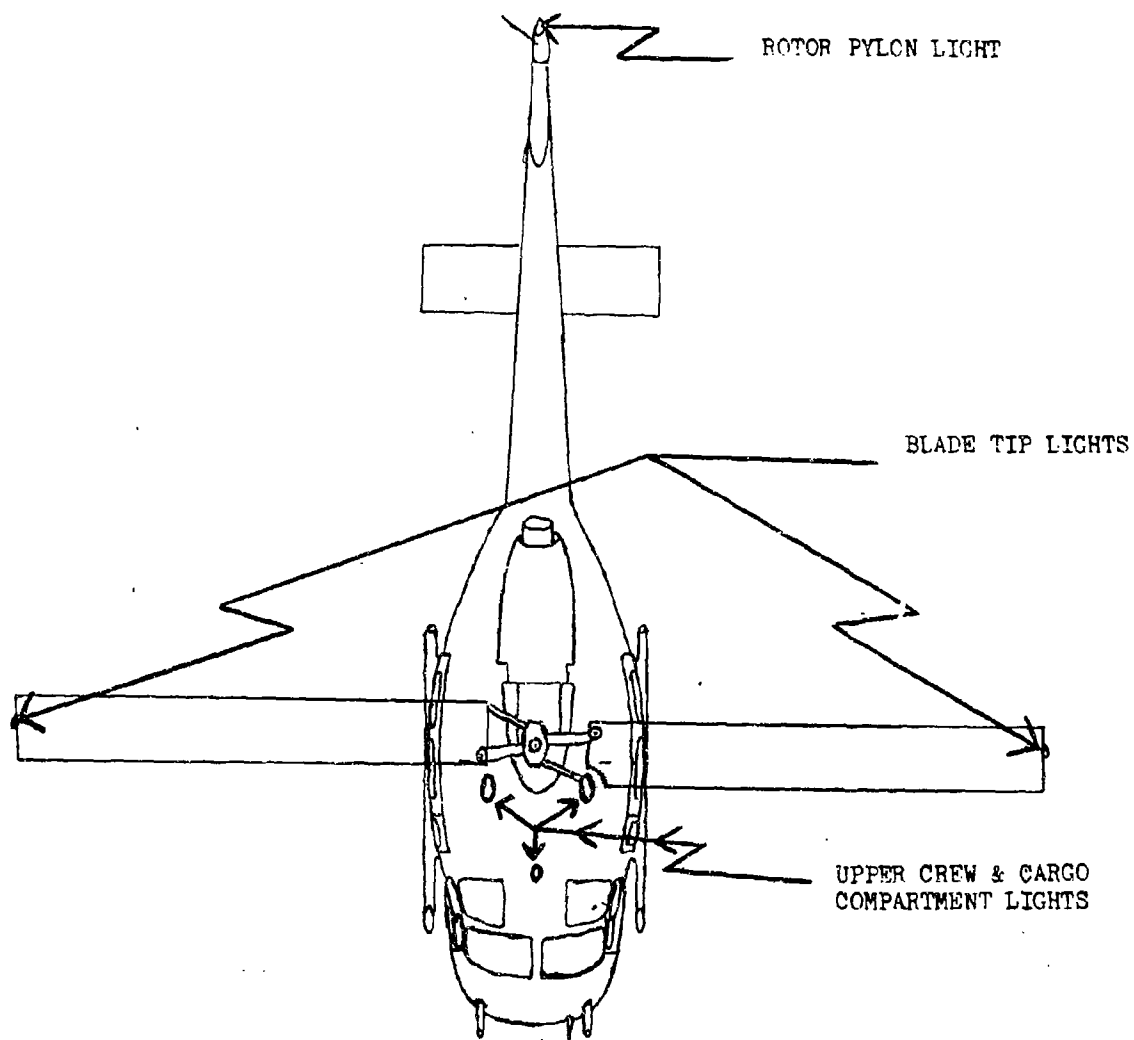
FIGURE 1.

- (1) One on top of the crew compartment directly to the rear of the UHF antenna to emit light upward and rearward.
- (2) Two on top of the cargo compartment on opposite sides of the transmission fairing to emit light upward.
- (3) One on the antitorque rotor pylon behind the FM radio antenna to emit light upward and slightly rearward.
- (4) One rotor blade tip light mounted on the outboard end of each main rotor blade to emit light upward and outward. (Figure 1)

Installation of Lights on Blades and Fuselage.

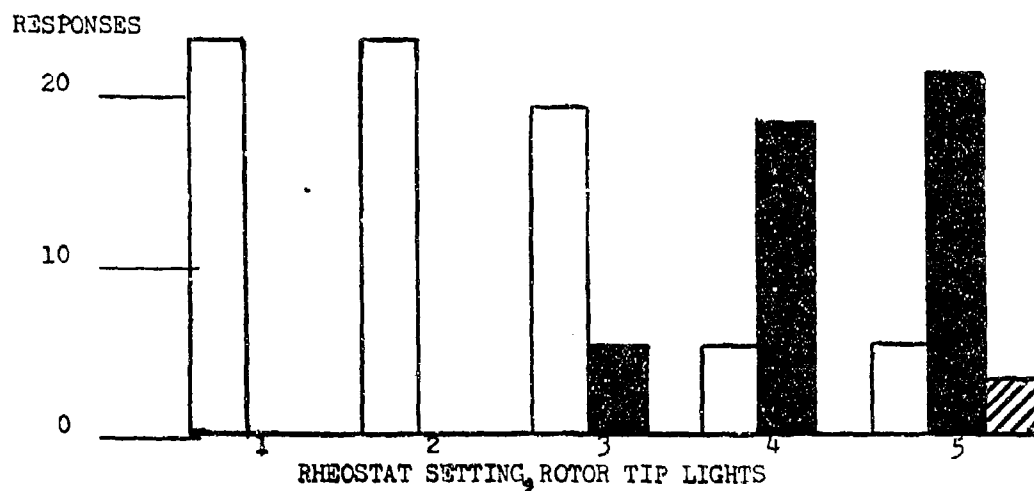
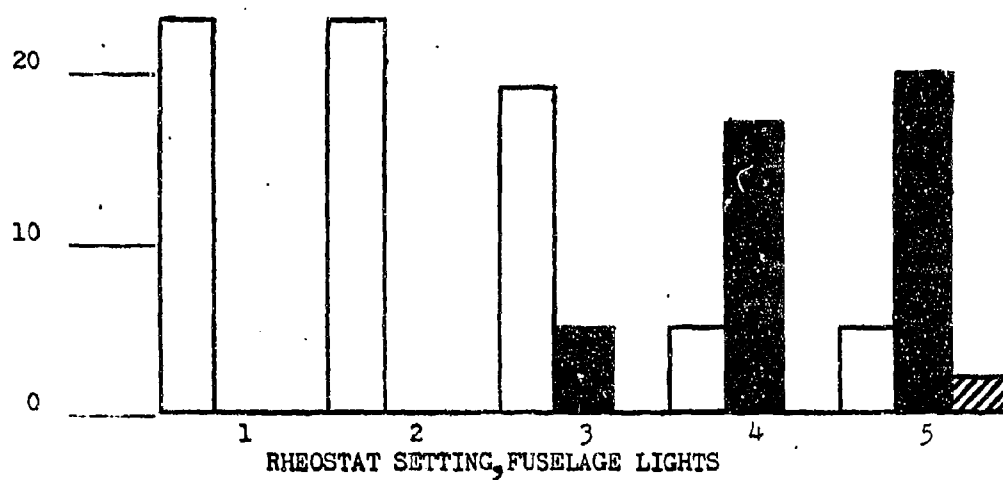
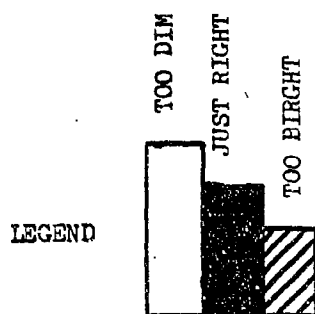
FIGURE 4. Light Intensity

(1) Figure 4 illustrates pilots' opinions of the intensity of the fuselage and rotor tip lights for all possible rheostat settings. Some were of the opinion that both systems could be brighter; however, most thought the lights were satisfactory at the maximum intensity setting.

(2) With lights turned up to maximum intensity, they could be seen at distances greater than a mile away. At any setting below number 3, all lights were extremely difficult to see, even when in close formation.

(2) When rheostat setting 1 or 2 on either circuit is used, lights are too dim. If technically feasible, these settings should be deleted and two higher intensity settings added. This would increase the maximum intensity by two increments.

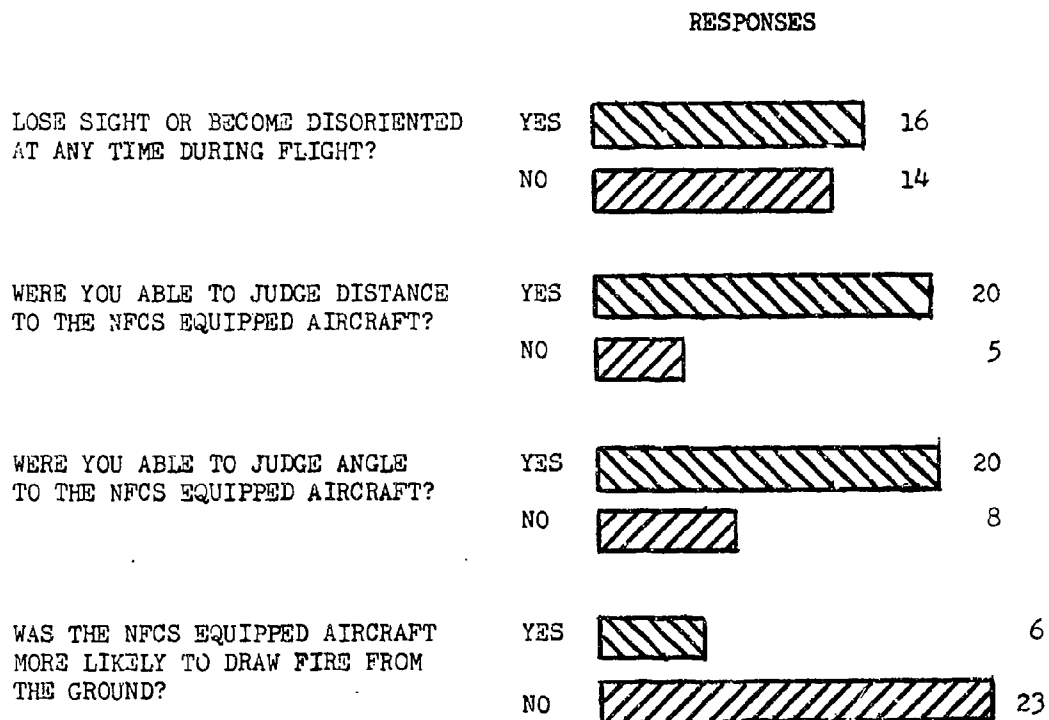
FIGURE 5. Pilot Responses to Specific Questions

Generally, pilots adjusted to flying with the NFCS very readily. However, as indicated in Figure 5, about 50 per cent of those responding became disoriented at some point in flight. Most disorientations were attributed to two causes. First, whenever number 1 aircraft turned away from number 2 and the number 2 pilot lost sight of all lights on number 1, he became disoriented and usually had to break out of formation and then rejoin. Second, many pilots became confused with the panel lights and had difficulty determining which two lights they should line up to maintain correct position. All panel lights were the same color and shape.

(3) Panel lights on the fuselage were all the same size, shape, and color. This caused pilots some confusion in orientation. A distinctive color combination such as a red light on the left, a green light on the right, and blue lights at the front and rear positions would eliminate this problem.

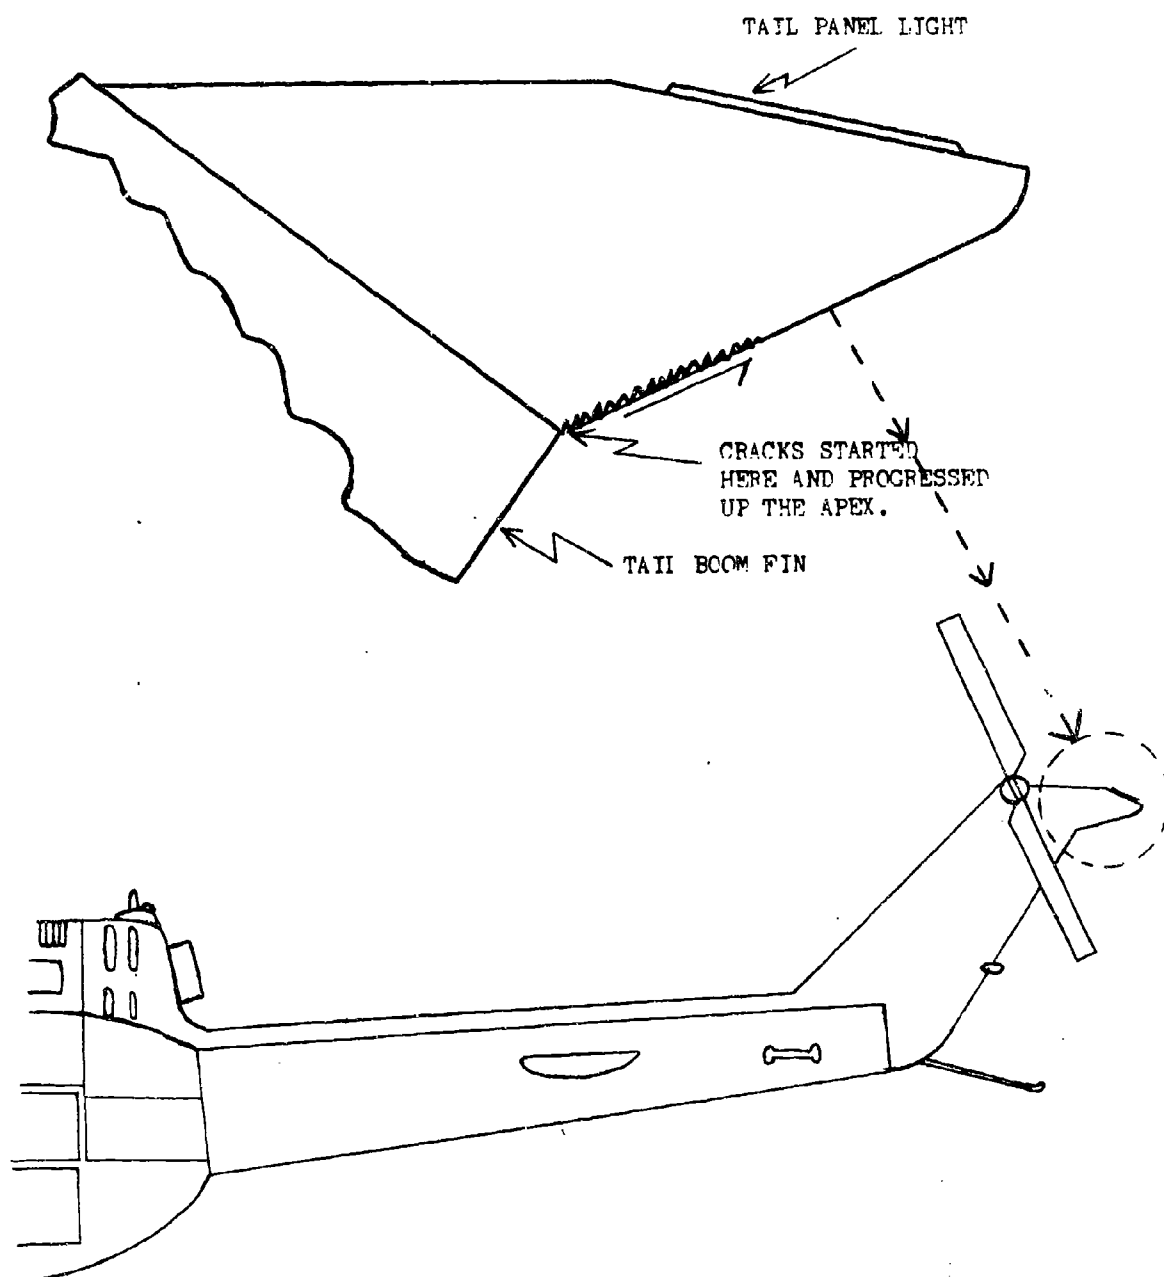
FIGURE 6. Diagram of Crack on Tail Boom Pylon.

(2) All fuselage light systems worked with no failures. One panel light was cracked, presumably when someone stepped on it. Three out of six tail pylon panel light mounts cracked along the rear edge. A simple repair job using a strip of fiberglass to reinforce the weakened area corrected this problem. (See Figure 6)

(4) The FM antenna support mount on which the rear panel light is mounted developed cracks and should be made of stronger material.
